BASTIÓN DE SAN DIEGO

INTRAMUROS ADMINISTRATION
MINISTRY OF HUMAN SETTLEMENTS

The conservation of Bastión de San Diego began on March 17, 1979. This initial effort to clear the structure of vegetation and waste led to the discovery of interesting architectural features, many of them previously unrecorded and photographed.

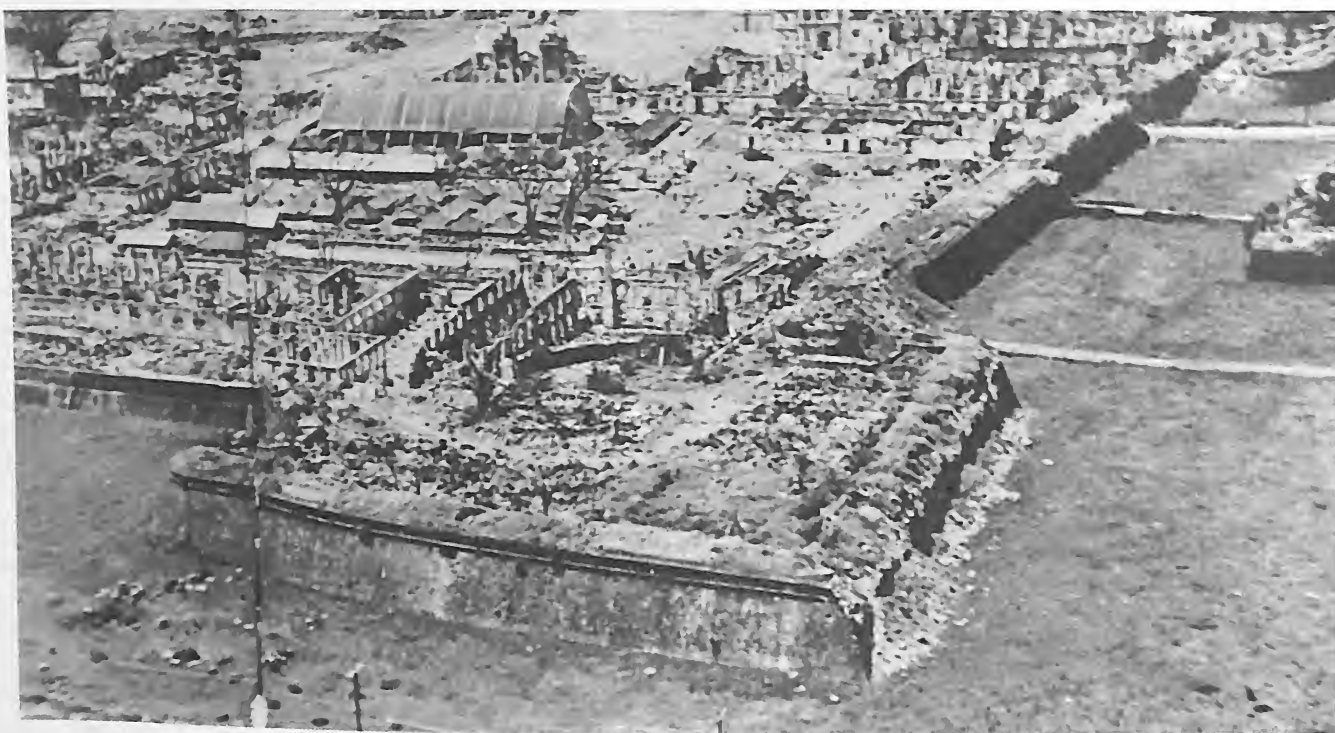
Figure 15. What remained of Bastión de San Diego and the surrounding establishments after the shelling of Manila in 1945. As in the British attack, the southeastern face of the bulwark bore the brunt of the bombardment. From among the ruins, one fails to identify the north garita.

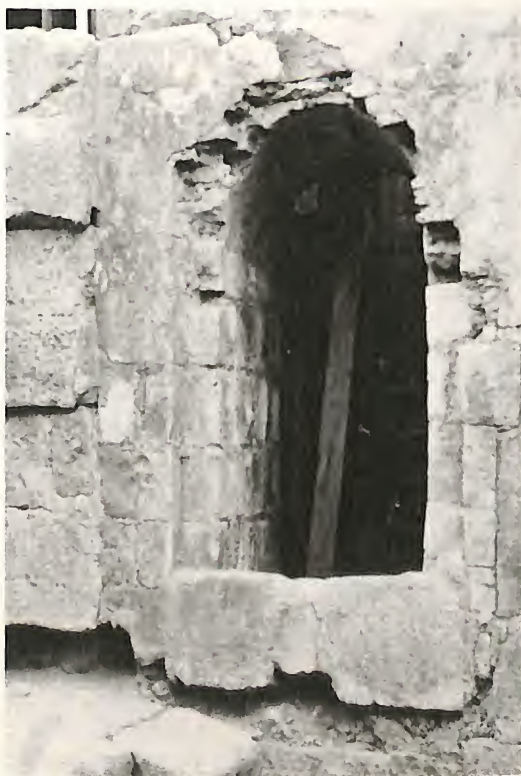
Figure 17. In the original structure, this narrow archway led to the patio. When the outer patio was backfilled with some 1.56 meters of sand, part of this doorway was blocked. Marks on the door frame indicate that it was fitted with a door.

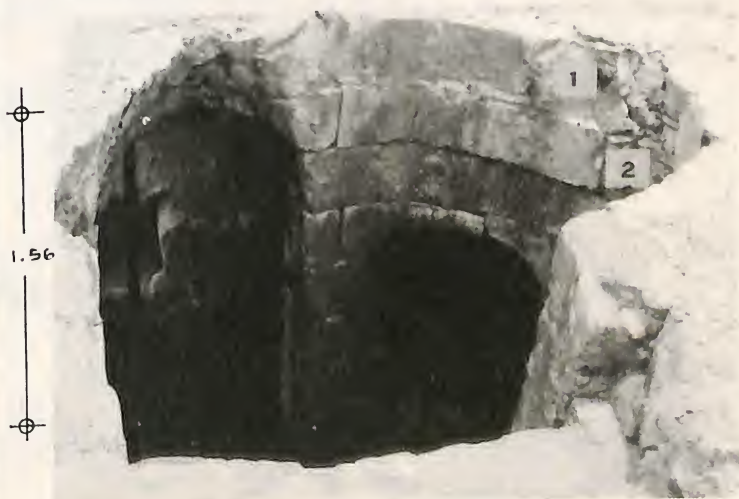
Figure 18. A view of the stairwell. Acroposts support some of the loose stones of the structure. Numbers one and two indicate missing stone members of the original winding staircase.

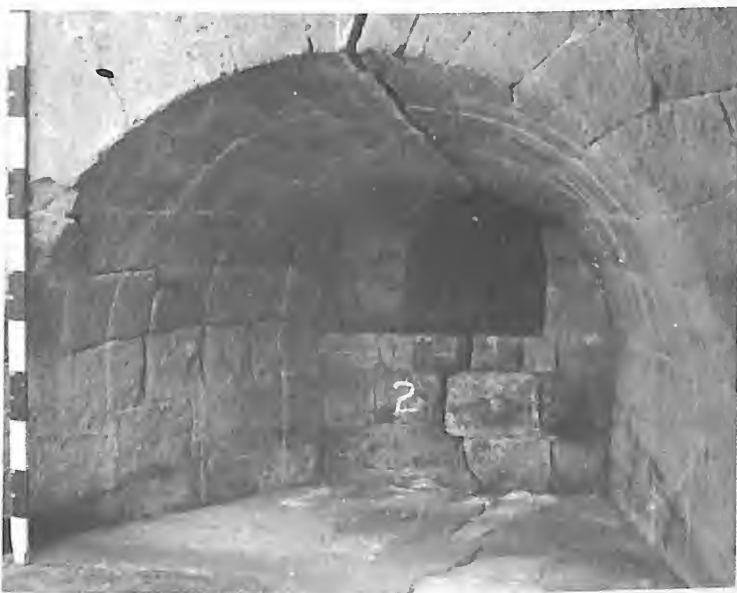
Figure 23. Casemate No. 2 has a deep crack running through its ceiling. It is similar in construction to casemates 1, 3, 7, 8, 9 and 11. They are characterized by a wide opening that narrows down in the interior. All have lookout windows, though most of them are now sealed with adobe. Their floorings are paved and leveled.

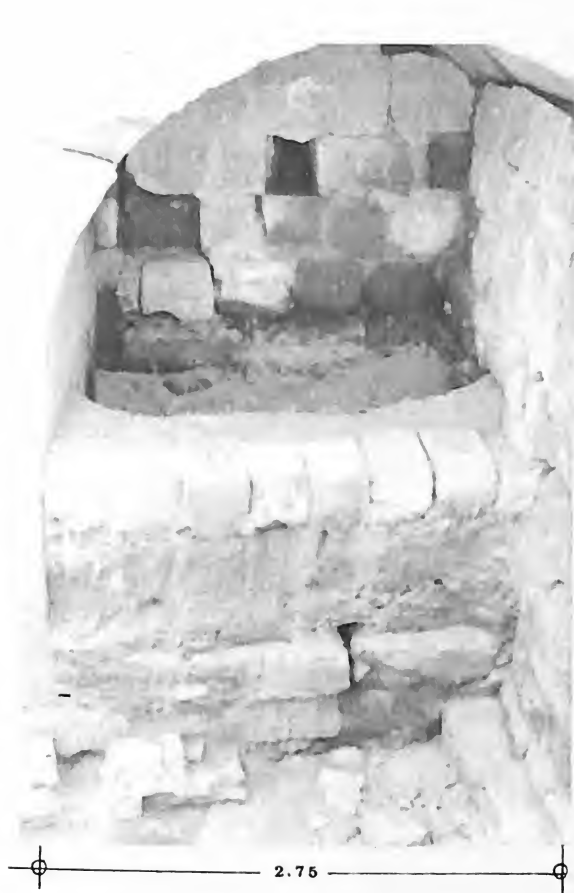
Casemate No. 6 appears in a "disturbed condition." Its opening has been partly sealed by adobe blocks from flooring till midway of the arch. Soil fills its inner cavity, in an attempt, perhaps, to raise the flooring. On the other hand, the flooring of casemate No. 4 follows the style or manner of the newer casemates.

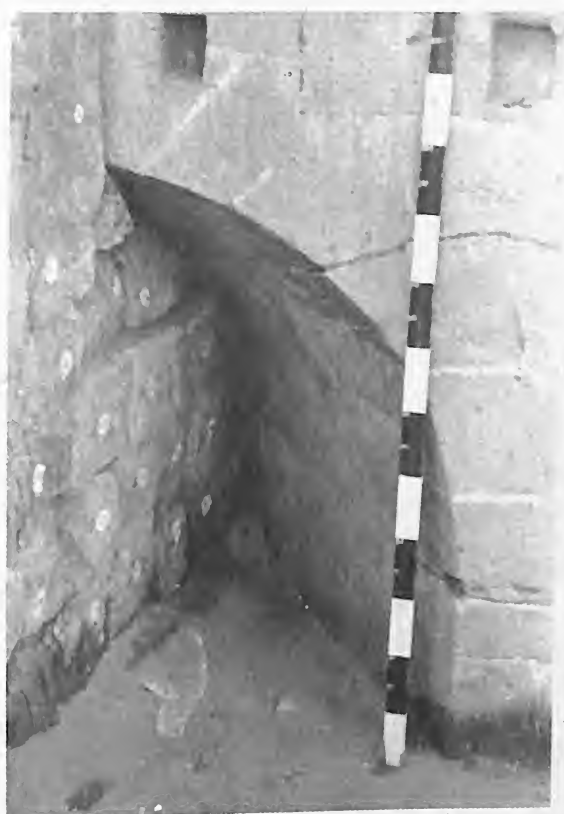
Figure 28. Casemate No. 7 has been totally obstructed by the spoke built right through its center. Like casemate No. 3, grooves on the outer wall by the entrance may be seen.

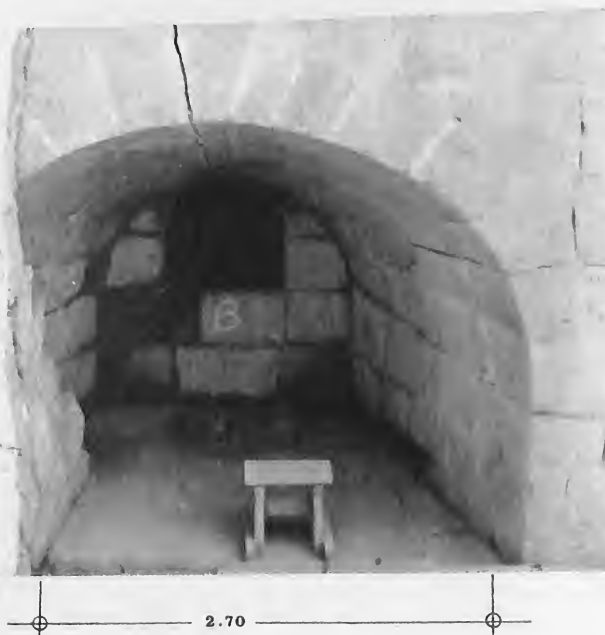
Figure 29. Casemate No. 8 manifests the same deep cleavage that has marred its otherwise perfect condition. The wall of one of the spokes partly encroaches on its opening.

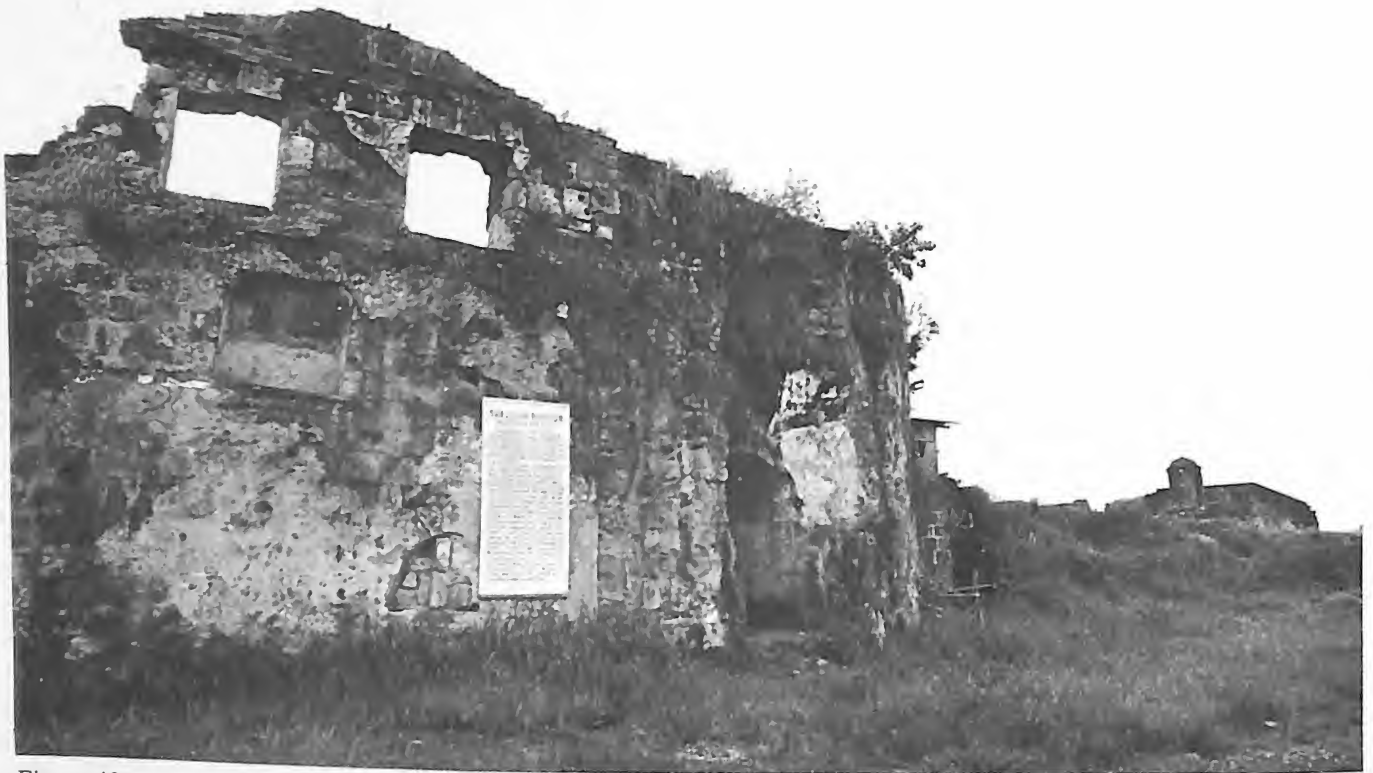
Figure 42. *The forlorn ruins of the Bastión de San Diego as it looked in September 1979. Its one surviving garita keeps a lonely watch on the north flank.*

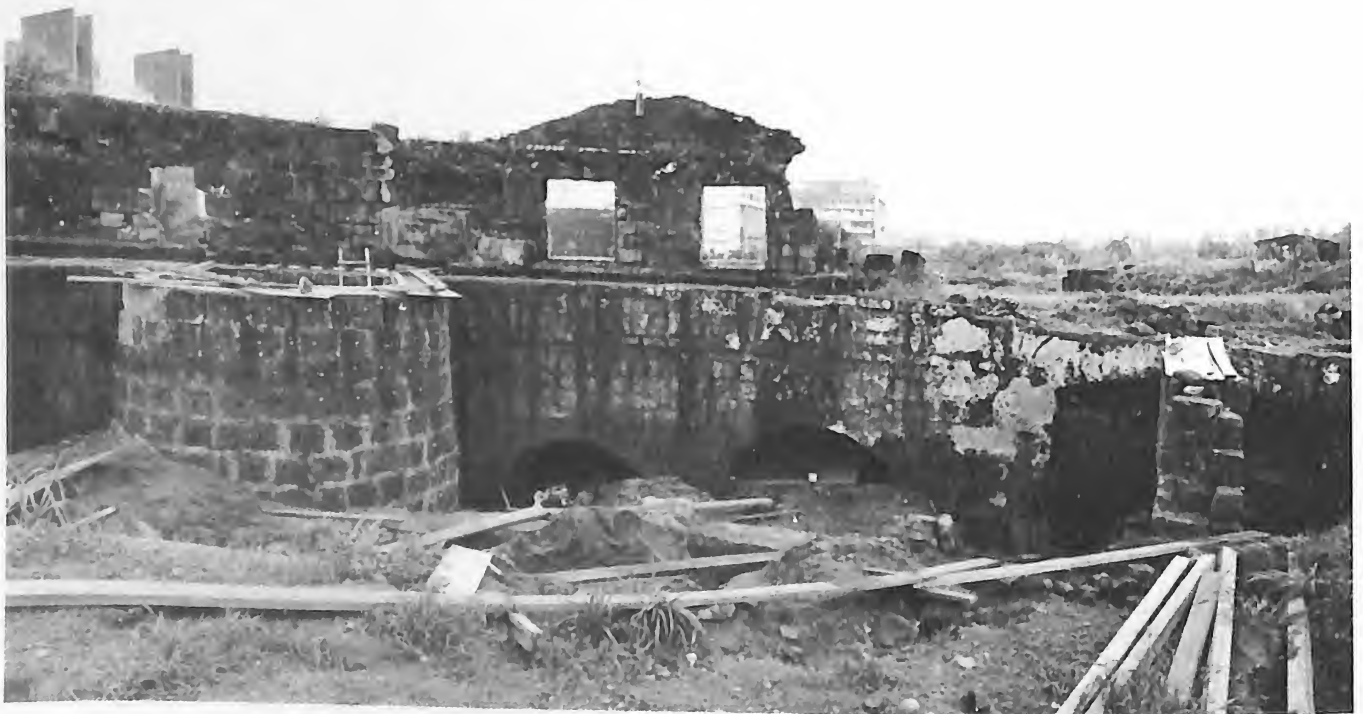
Figure 43. *The interior of the Bastión de San Diego presented a bleak view during the early stages of excavation. The Executive House is on the far right-hand corner of the picture, and to the left the concrete buttresses of the Pamantasan ng Lungsod ng Maynila cut through the Intramuros skyline to hold the earthquake-damaged building.*

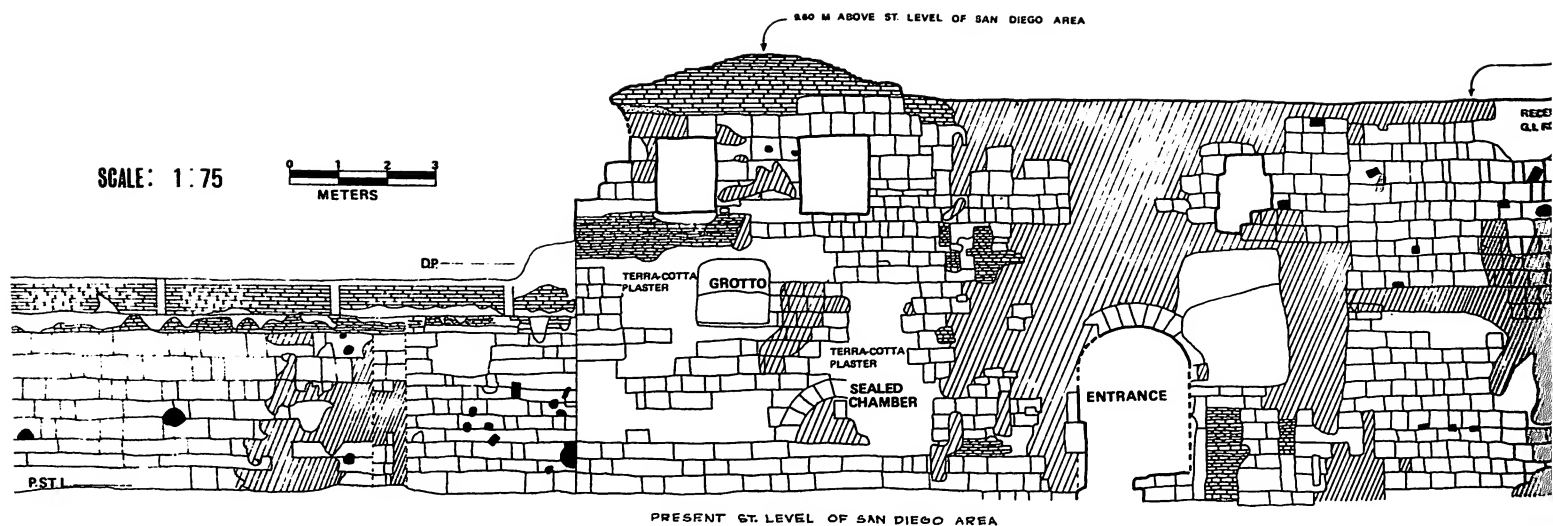
Figure 44. This documentation of Bastión de San Diego shows its actual state at the start of the restoration program in 1979.

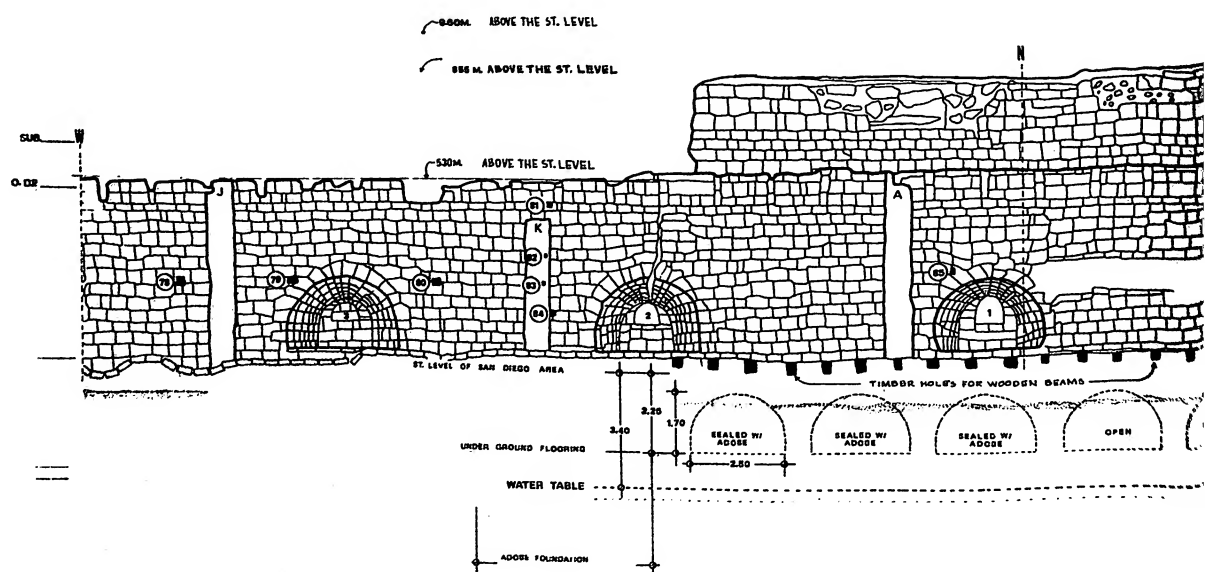
Figure 45, A and B. The documentation of the interior portion of the third circular structure showing the condition of the walls and casemates and the position of the buried chambers below the street level.

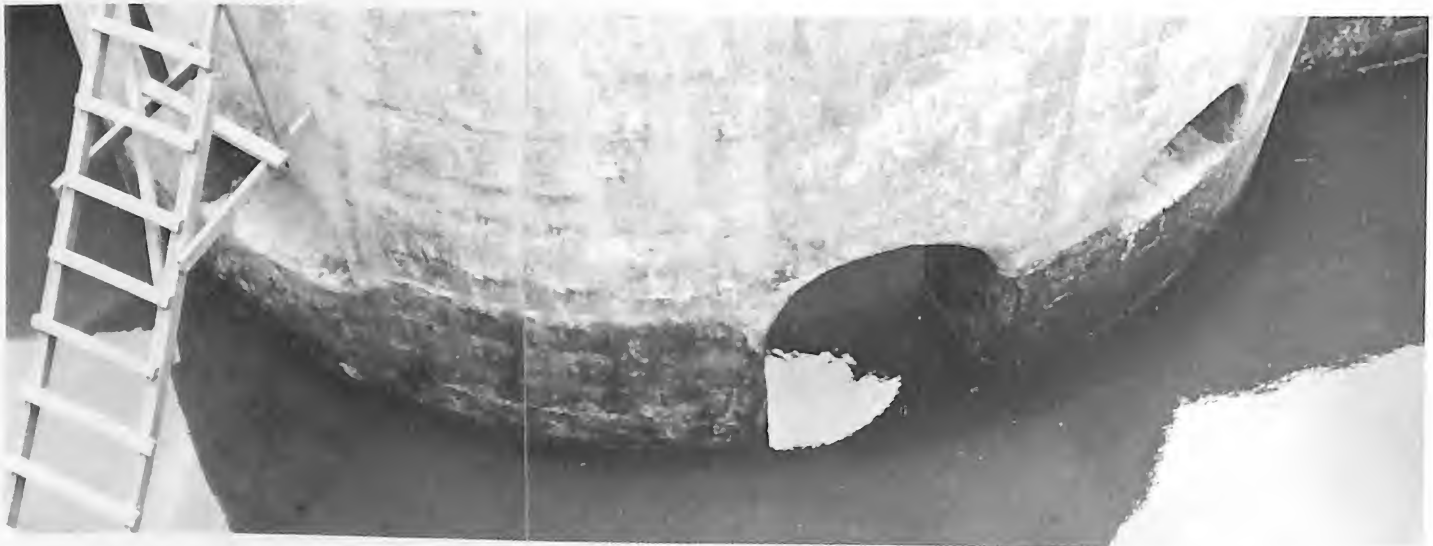
Figure 55. The exterior wall of the first circle showing the water mark indicating how high the water rises.

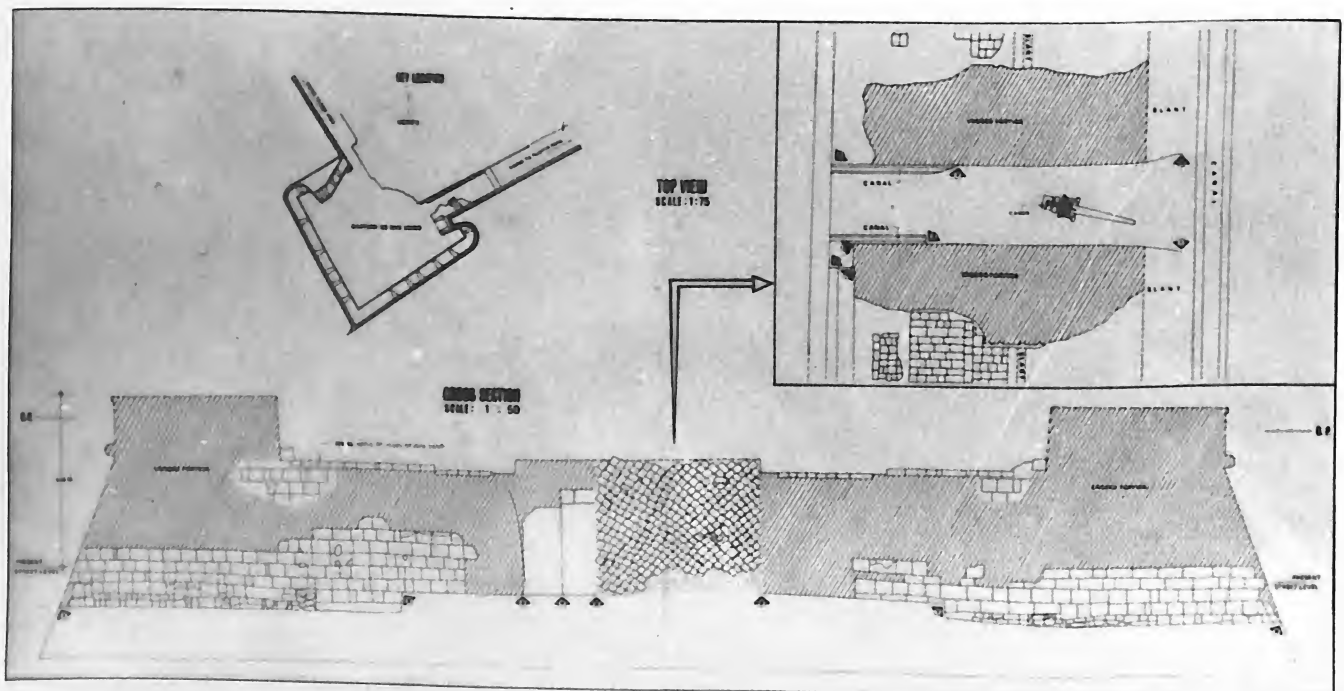
Photograph shows the condition of the west flank. The central portion of the drawing shows how mojonos—landmarks—were used to shore up eroding portion of the wall.

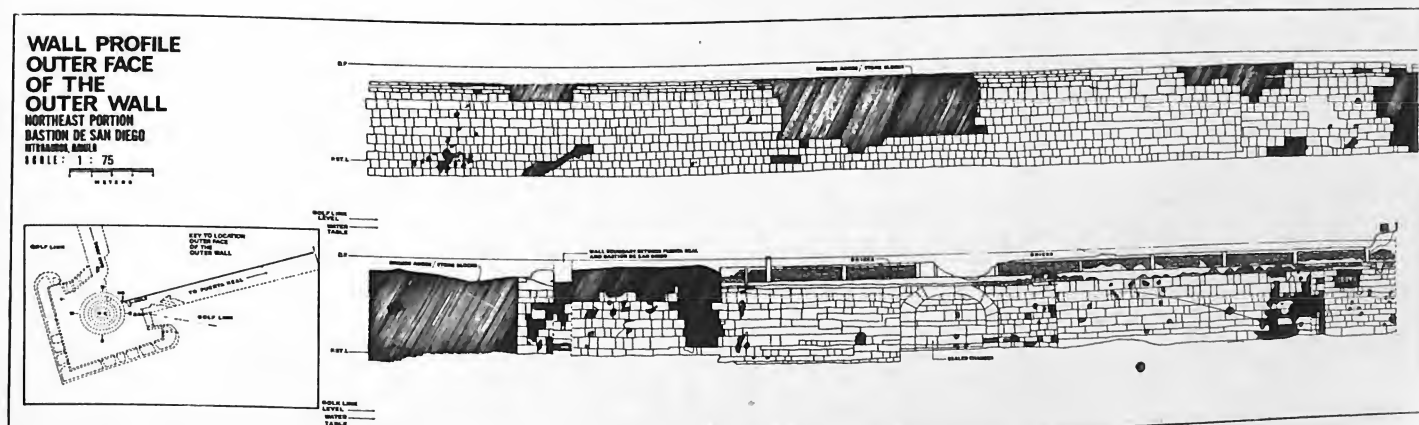
The condition of the wall on the northeast portion of Bastión de San Diego facing Muralla Street.

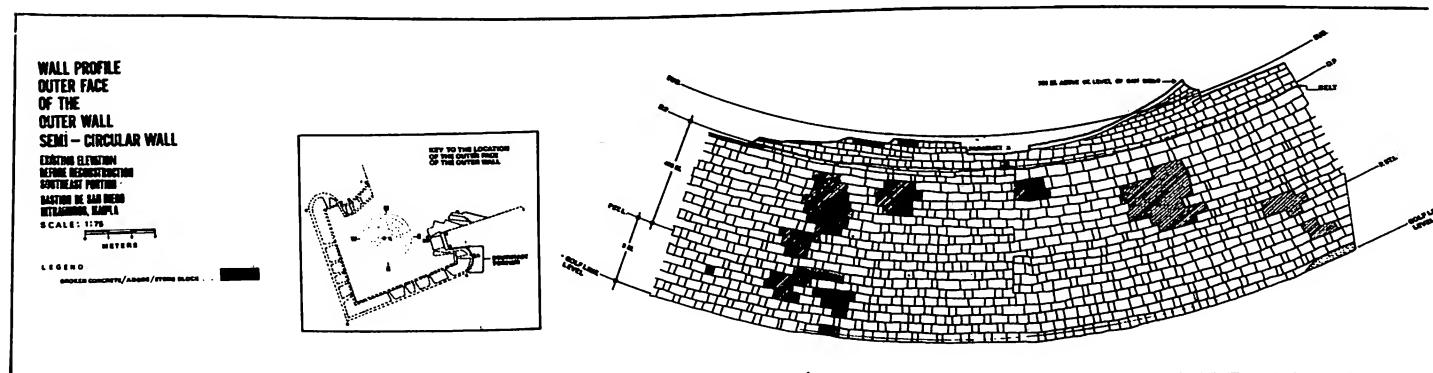
The condition of the eastern orillion and its elevation before reconstruction.

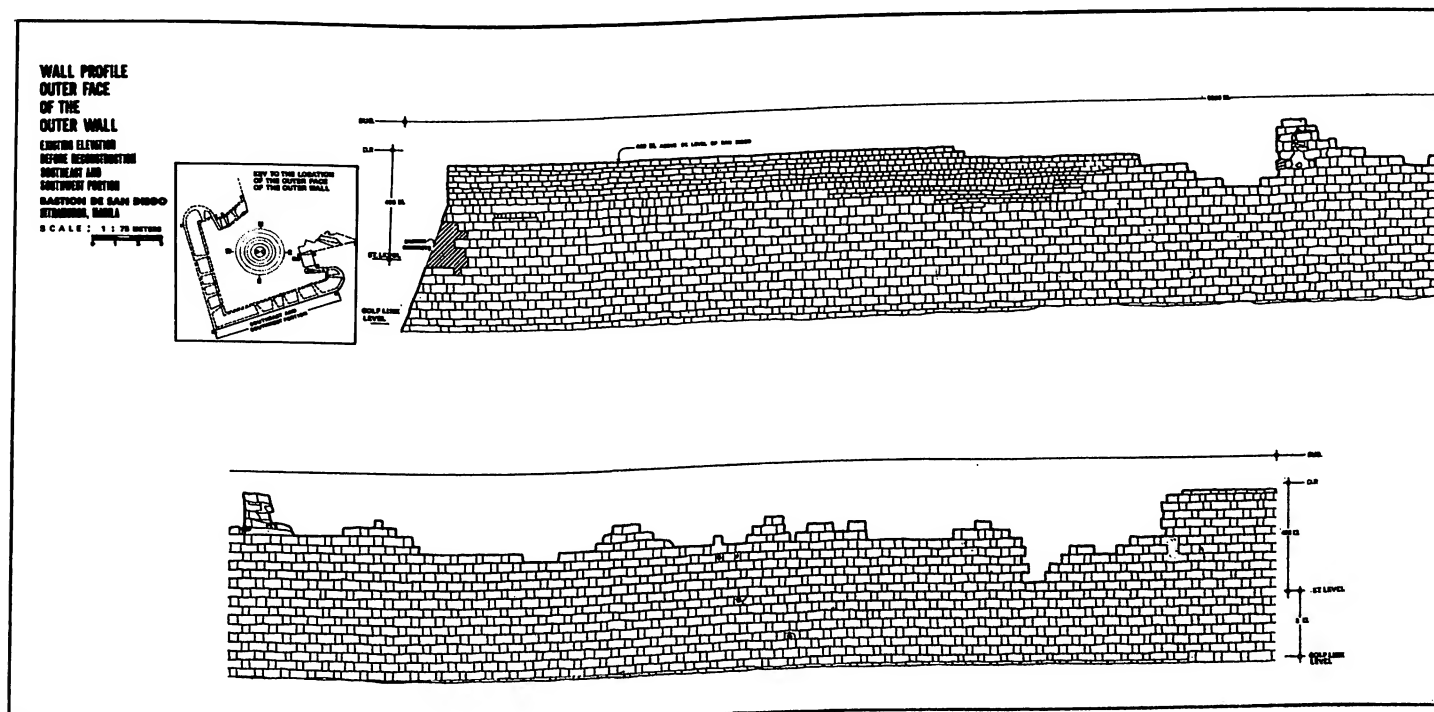
The existing elevation and status of the wall before reconstruction of the southeast and southwest portions.
